# **Goss talks Petrol Direct Injection - High Pressure Fuel Pumps (HPFP)**

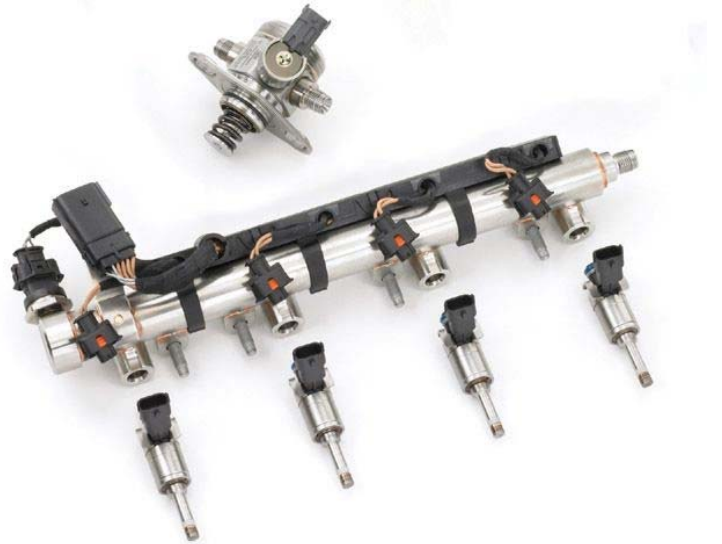
The High Pressure Fuel Pump (HPFP) is the main component in this system. It is responsible for compressing the fuel, supplied by the Electric Fuel Pump, to the pressure required for High Pressure Injection. The HPFP is mounted to the engine and mechanically driven by the camshaft, while the ECU is able to vary the output to match the load requirements of the engine. Various sensors and solenoids (listed below) provide inputs to ensure the system functions at maximum efficiency.

1. Pressure Solenoid – controls the volume and pressure of the HPFP by changing the stroke and port location.
2. Pressure and Temperature Sensors – generate information for the best possible combustion condition.
